SKYMASTERS

The promise was safety in single-engine operation. The promise was fulfilled; but the Skymaster saga shows that safety, as usual, doesn't sell.

BY THOMAS A. HORNE

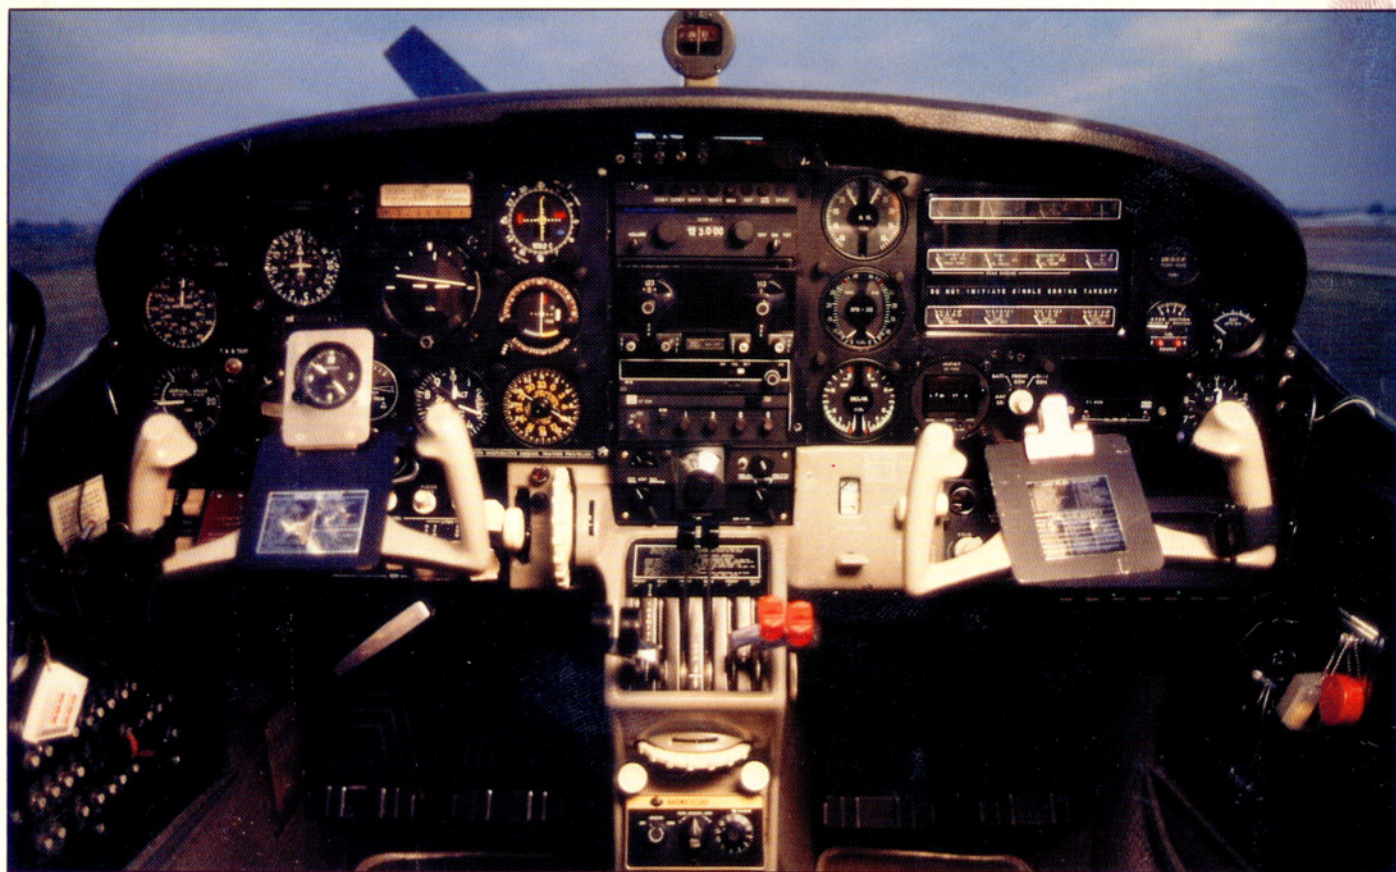
The Skymaster photographed for this article, owned by Dr. Robert Poole of Washington, D.C., is a 1965 Model 337. The power quadrant can cause confusion at first. The right levers control the rear engine (just remember Right—Rear); the left levers, the front engine.

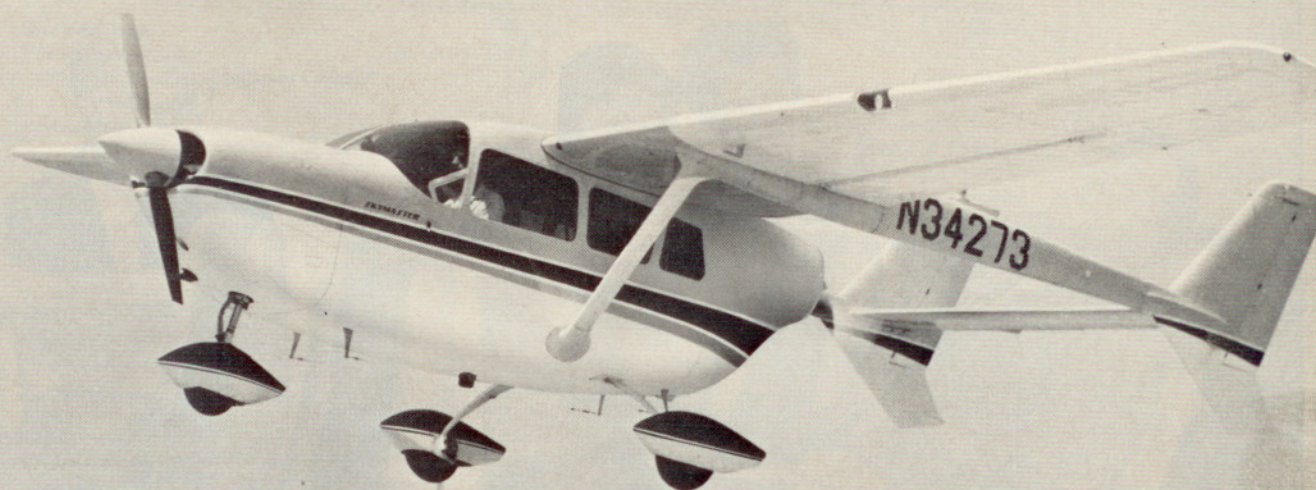
Cessna went overboard to demonstrate the Skymaster's engine-out directional stability. This 1963 promotional photograph shows a 336 taking off with the front propeller feathered. Such stunts helped encourage some pilots to do the same, with unsuccessful results.

ate Single Engine Takeoff." This is ironic, since early promotional photographs showed a Skymaster being pushed into the air on one engine. Accident records have shown that Cessna may have set a bad example.

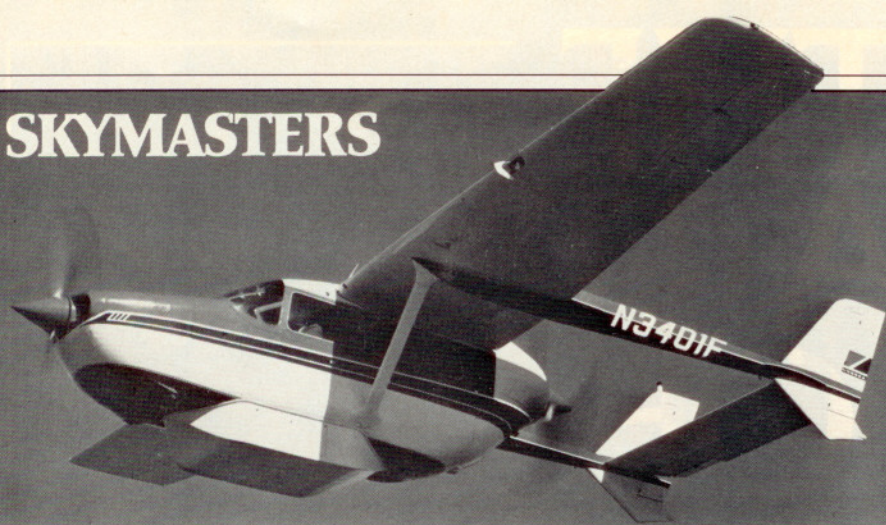
The optional cargo pods expand the Skymaster's utility, but cost you speed and looks.
