# USED TURBINE REVIEW

## CHEYENNES: THE I, IA, II, AND IIXL

*Step-up turboprops that offer capability but demand respect*

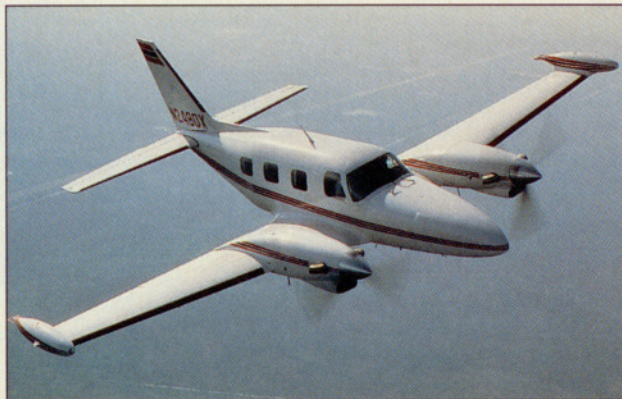
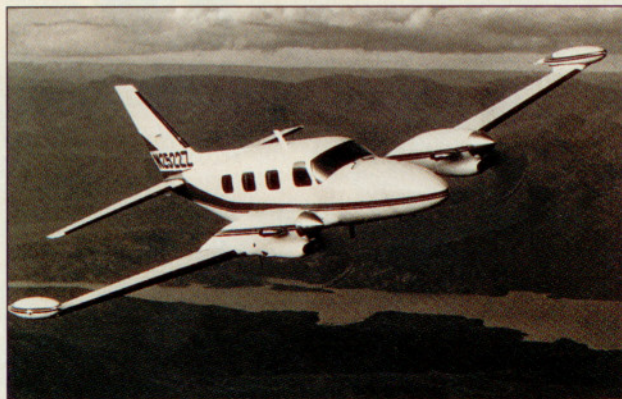
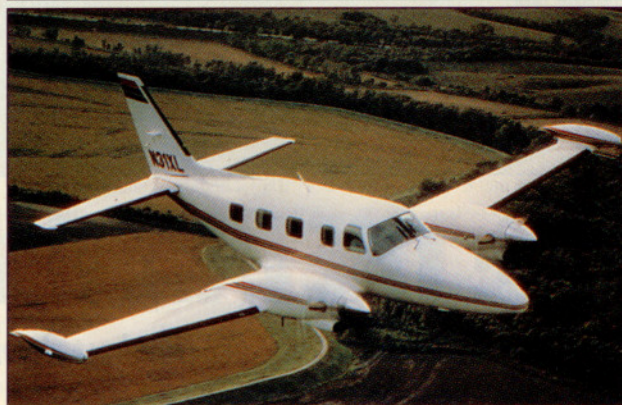
When the Cheyenne was brand-new, Piper sent a "blue-printed" version on a road show. Succeeding models (left, top to bottom) included Cheyennes I, IA, and IIXL. A 1982 Cheyenne II is featured on the title page.

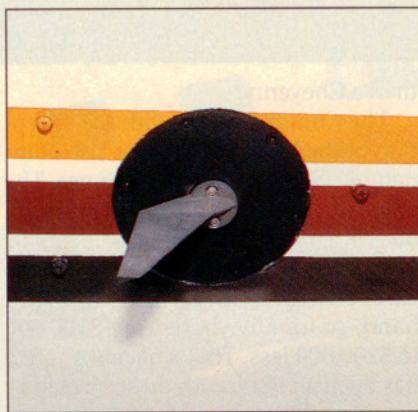
*The SAS's angle-of-attack vane.*

Enter the SAS. When this system detects low airspeed and high angle of attack, it activates a variable-pressure elevator downspring to provide the proper control feel. Piper designed the SAS so that when the Cheyenne's airspeed drops below 125 KIAS, the downspring begins applying forward pressure on the control column. At 100 KIAS, the downspring exerts maximum nose-down force. To back up the SAS in case of a failure, an emergency system is provided. To activate

Other recommended procedures include starter-generator overhauls every 1,000 hours and replacement of the SAS downspring pivot points every 2,000 hours. Other SAS maintenance is also very common. The angle-of-attack vane's potentiometer often fails. ("I replace about one a week, on average," says Salentano.) Periodic adjustments of the elevator downspring pressure are also required.
